Earth-fill Dam-Nelson Island, BC

GES Geotech completed a Dam Safety Inspection for the property owner of an existing small dam located in Nelson Island, BC. This project was carried out between 2008 to 2012. After reviewing photographs and available geotechnical information, GES performed a site reconnaissance.

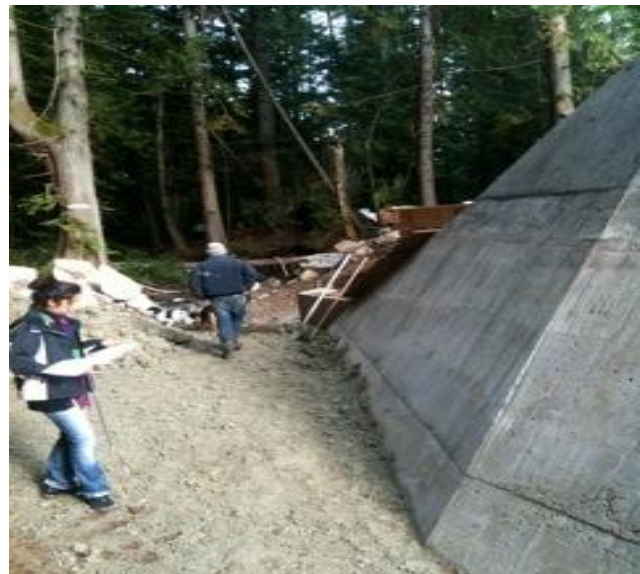
Excavation of ineffective dam body and construction of a new dam was selected based on drawdown mechanism system consideration and the significant hazards due to potential dam breach and ensuing water erosion.

The client dismantled the old crib-wall and later built an earth-fill dam with clay central core. GES completed the dam and spillway design, which included 400-900 mm riprap for protection against wave action. GES also attended site to review that dam construction was in general conformance with our design.
